MAJOR REPAIR AND ALTERATION
(Airframe, Powerplant, Propeller, or Appliance)

1. Aircraft	Make TAYLORCRAFT	Model BC12-65
	Serial No. 2635	Nationality and Registration Mark N29787
2. Owner	Name (As shown on registration certificate) TIMOTHY J. POPP	Address (As shown on registration certificate) P.O. BOX 4619 PALMER, AK 99645

USA, N29787, 10 March 2000

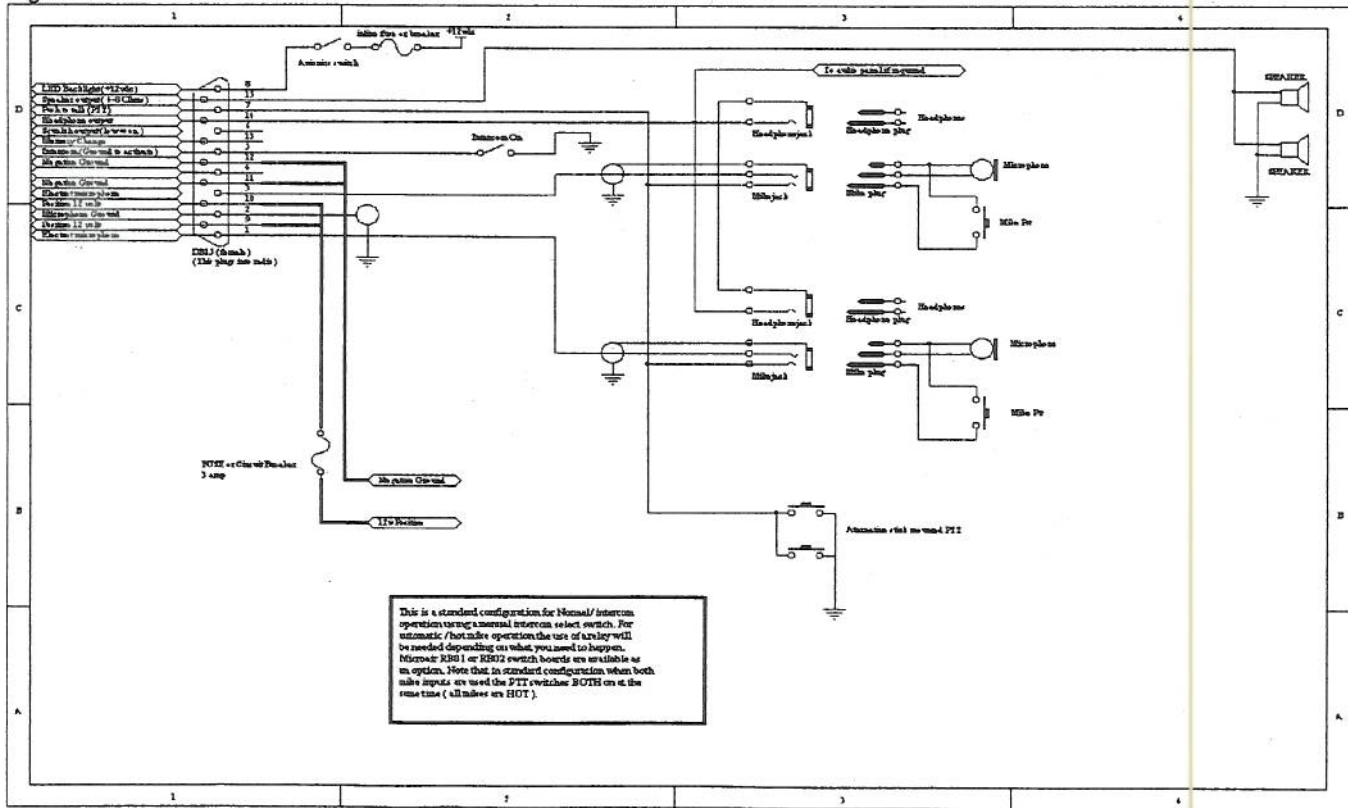
7. Figure 1.

6. Radio assembly is wired per figure below with aircraft grade 22 AWG shielded wire, except 18 AWG shielded wire is used as the power wire from the battery, also the external speaker option is not installed. Antenna utilizes RG58 coaxial cable per manufacturer's instructions.
